## Water Penetration Investigation

Air Tamarack Inspection Protocol

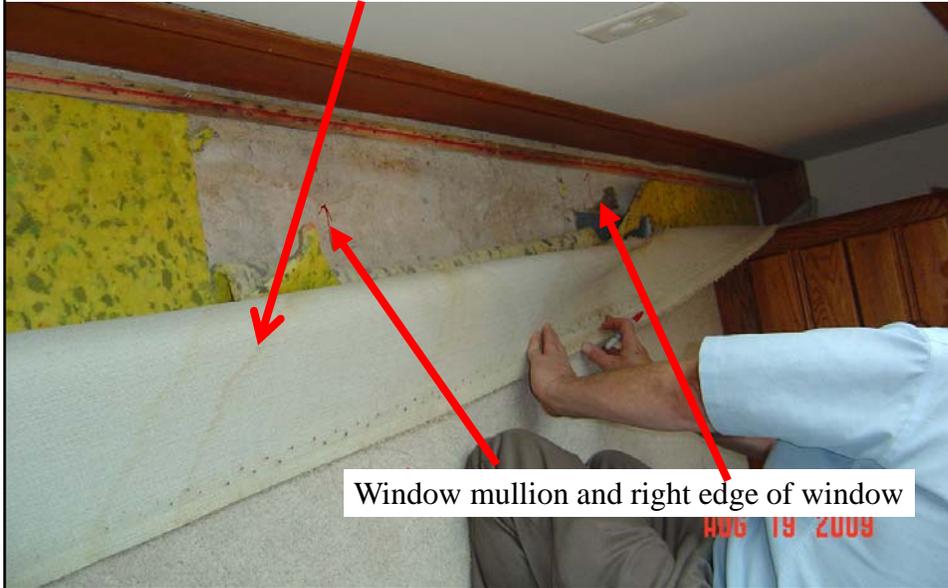
Carpet near exterior walls is pulled up and we look for evidence of water penetration as can be seen below which is showing evidence of water penetration – notice the discoloration in the carpet and in the subfloor

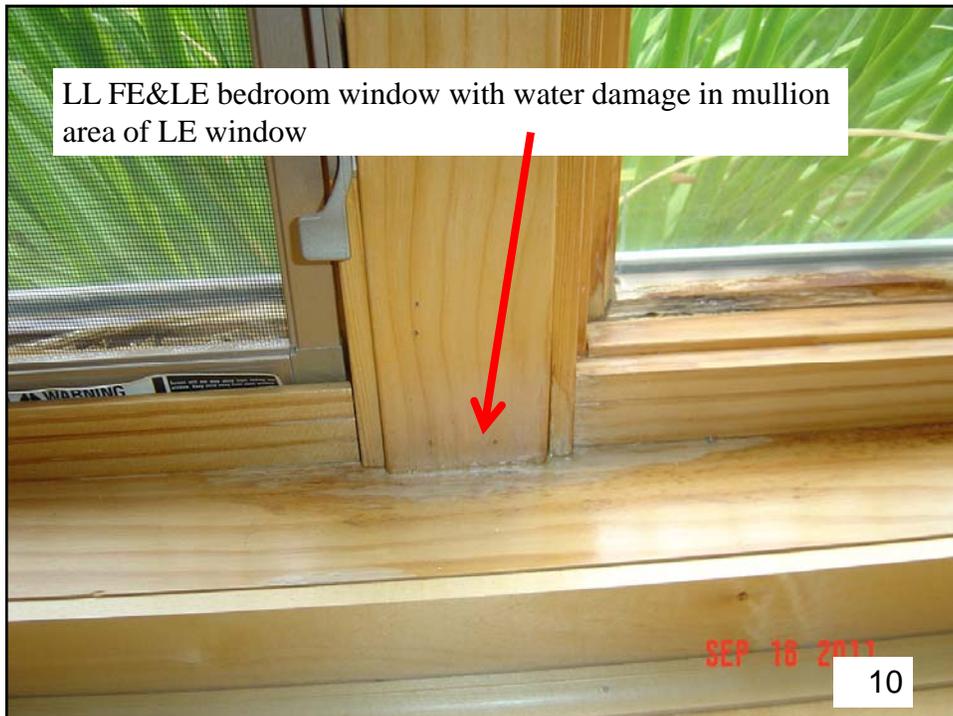
LL FE&LE bedroom window with water damage in mullion area of LE window

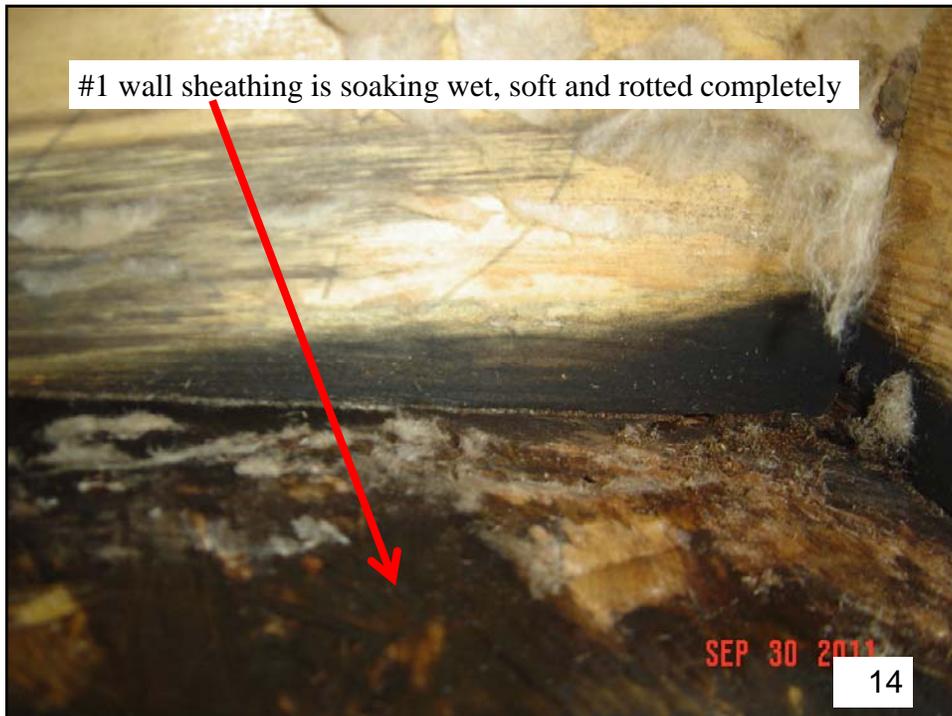
#1 wall sheathing is soaking wet, soft and rotted completely

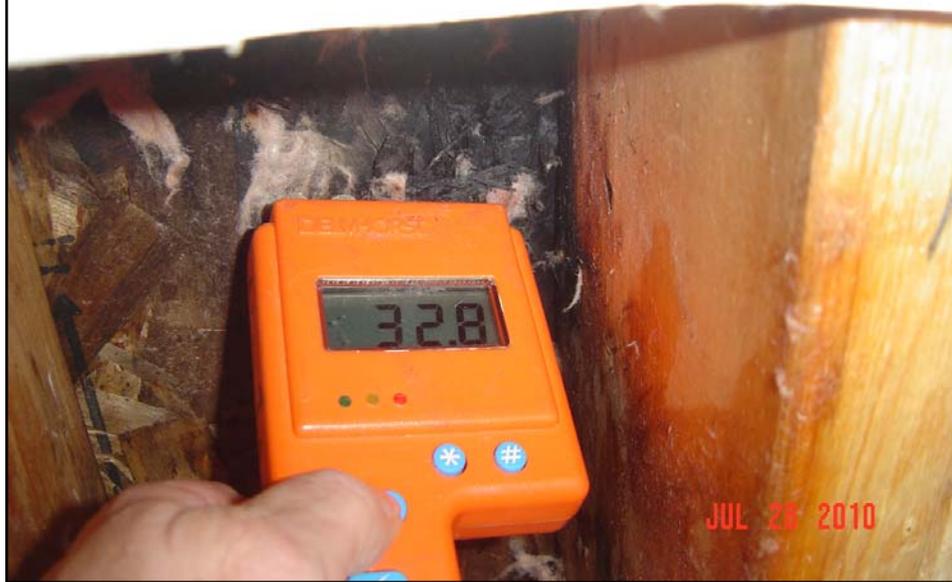
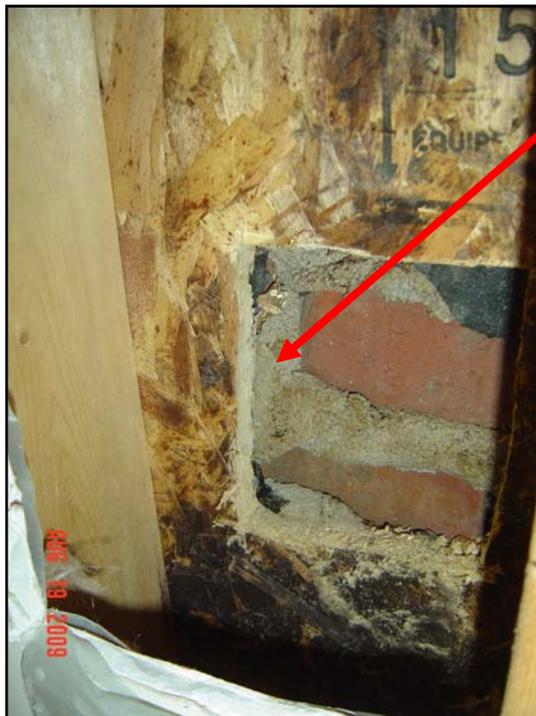
#4 wall sheathing below this window is in the rot zone
