## Water Penetration Investigation

Air Tamarack Inspection Protocol

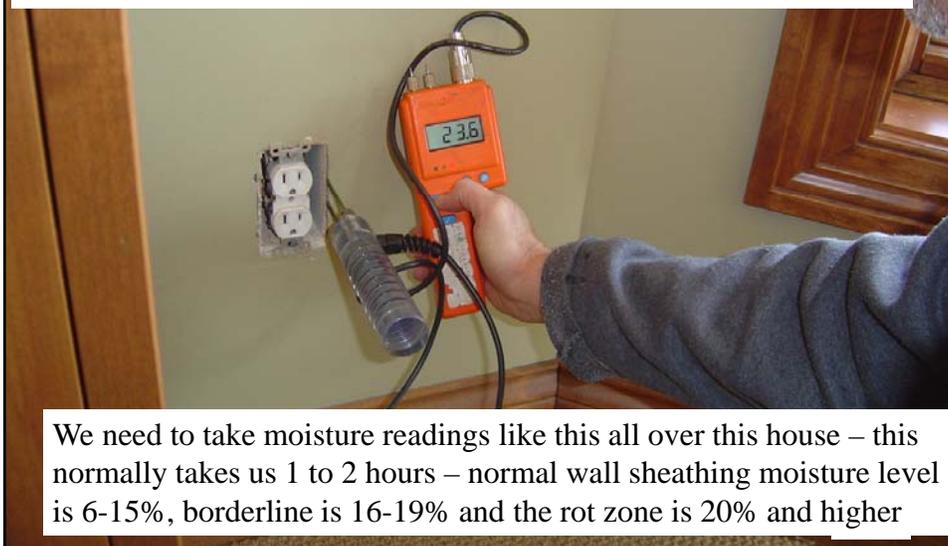
Moisture readings are taken beside electrical boxes – this method of testing doesn't work if the electrical box has a sealed flange around it. Most houses do not have sealed electrical boxes and this testing method works well.

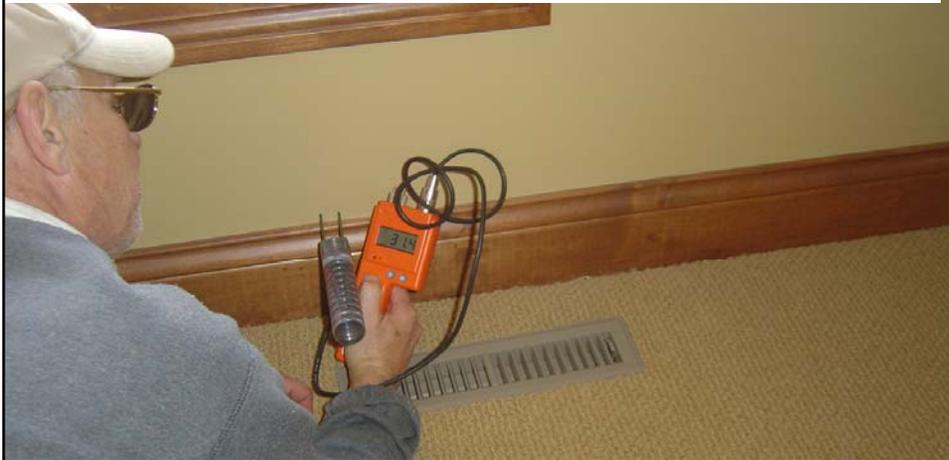
If we can't take moisture readings beside electrical boxes we would like take readings directly above the base wood trim as shown below:

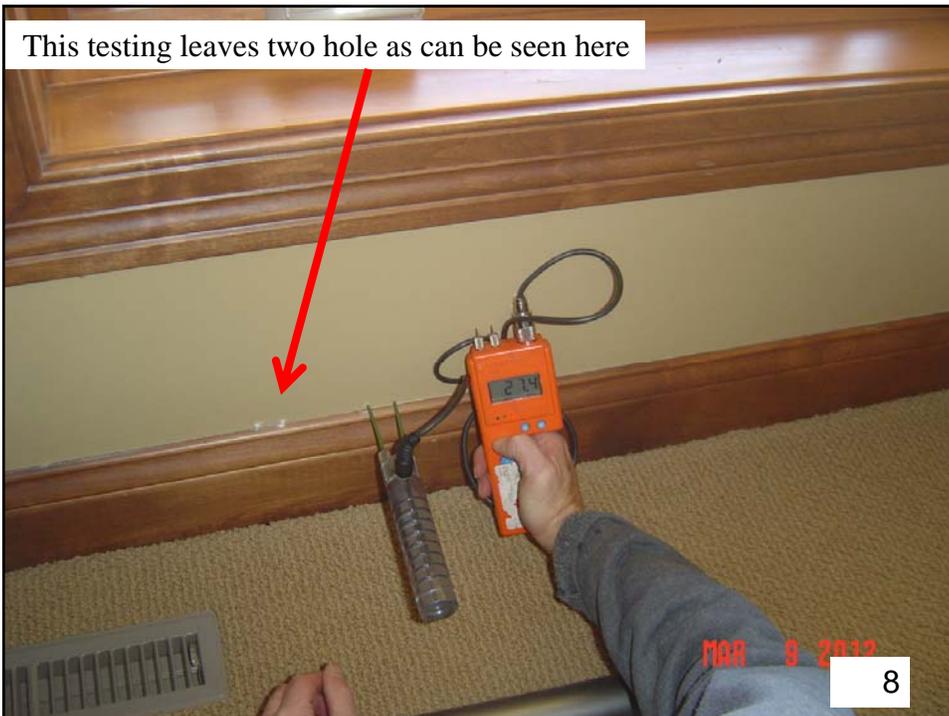
This testing leaves two hole as can be seen here

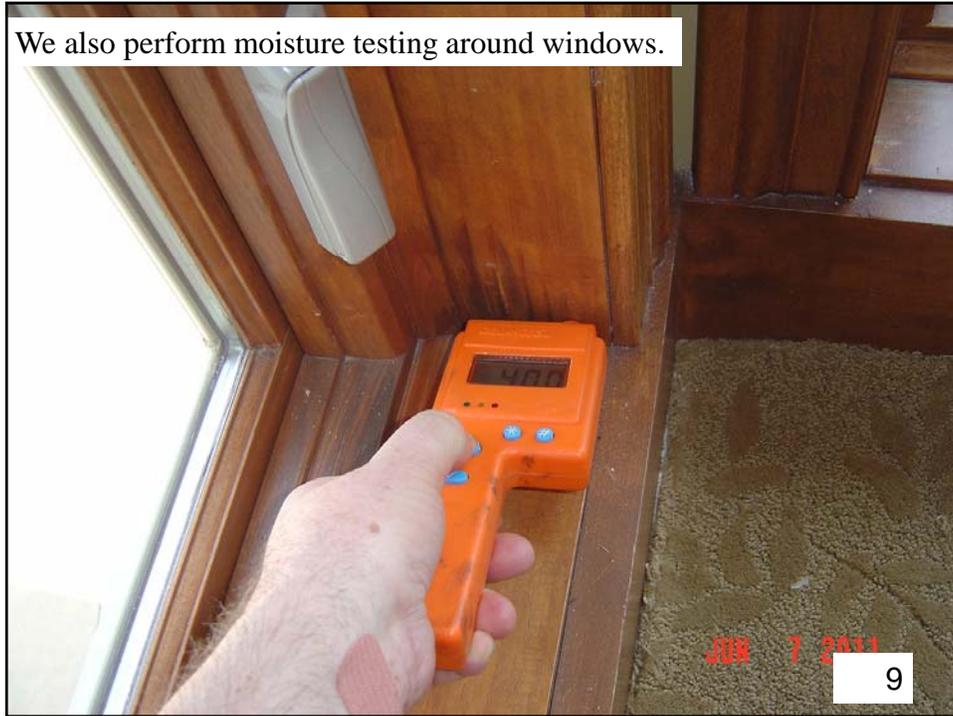
We also perform moisture testing around windows.

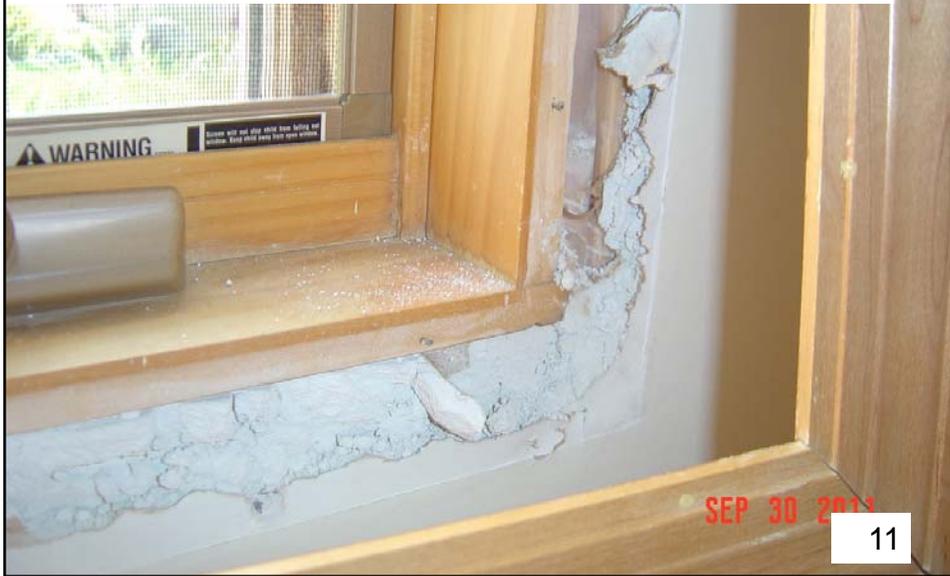
At one or two windows we may want to take the wooden trim off around the window to determine flashing methods and moisture in the wall assembly

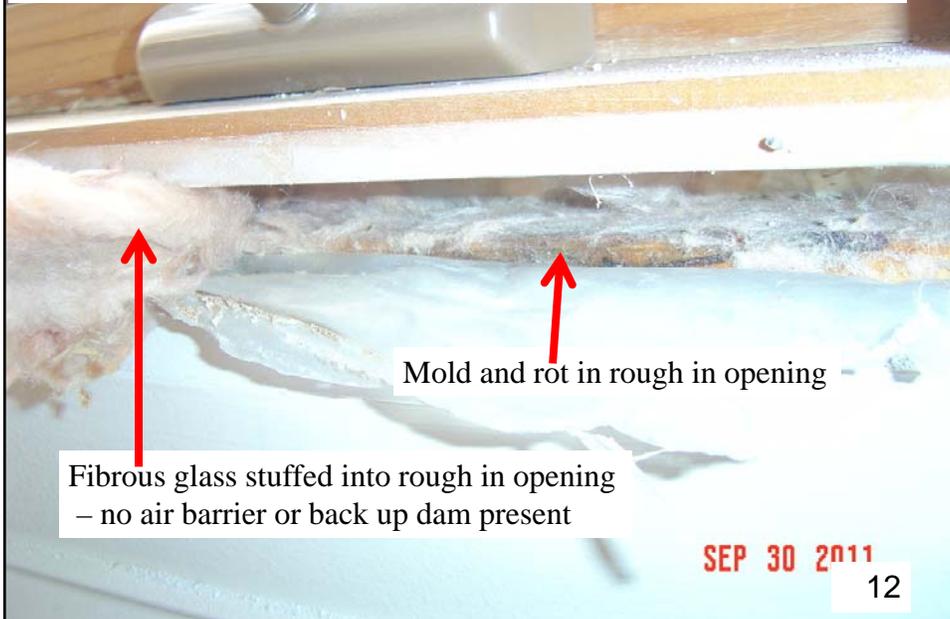
Opening up the wall around a window can tell us a lot about what is going on inside the wall.

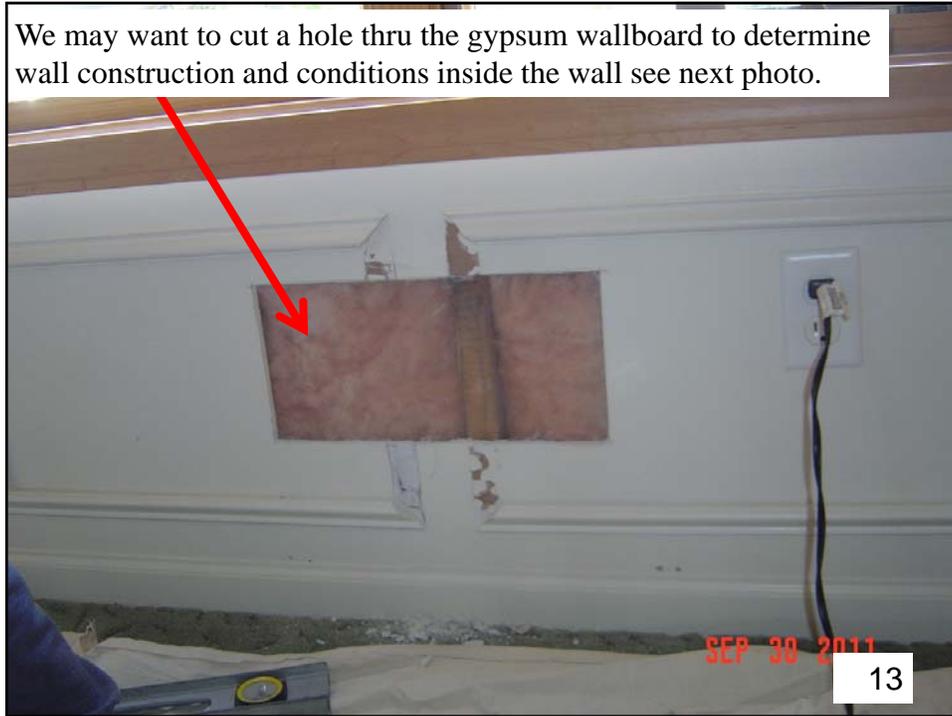
We may want to cut a hole thru the gypsum wallboard to determine wall construction and conditions inside the wall see next photo.
